## **INVESTIGATION**

**Bryson Crash**

RFI#22SC0121

#### **EXPERT'S SUPPLEMENTAL REPORT**

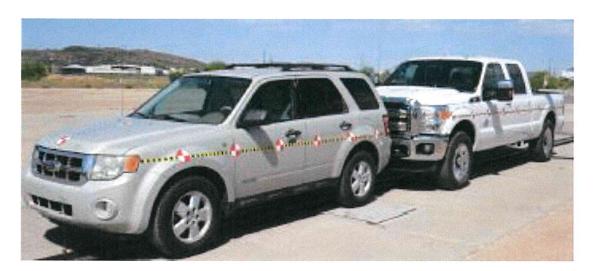
**Image 1: Pre-Test Vehicle Condition**

Both vehicles were ballasted, instrumented and the impact velocity of the F-250 was reported as 49.9mph with the test set up so that the front of the F-250 struck the rear of the Escape. The Escape was positioned to the right of the F-250 (and the test guide rail centerline) with an offset of about 10.8". To date, there has been no opportunity to inspect the tested vehicles. Image 1 shows the pre-test impact configuration.

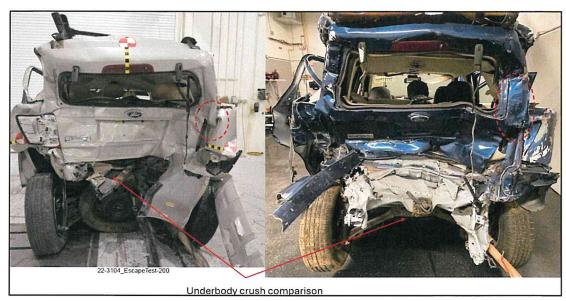
Image 2: Deformed Escape Comparison - Rear View

- 12. The tested Escape exhibited significantly increased underbody deformation than the subject Escape - Image 2 shows a comparison of the two vehicles, with the tested Escape on the left and the subject vehicle on the right. The tested Escape's underbody has been deformed, the rear rails are not exposed, and the rear floor is not visible. There was vertical alignment of the vehicle energy absorbing structures in the test.

- 13. The lateral vehicle overlap in the test does not match the subject condition. Image 2 shows that the right side of the subject liftgate pillar exhibits direct contact deformation (circled), whereas the tested Escape exhibits induced damage, or non-direct deformation. This indicates that the alignment of the vehicles was further offset in the test than the subject crash, resulting in less lateral overlap and therefore less structural engagement in the crash test.

Additionally, the crash test overlap and setup are unrepresentative of the subject crash. The overlap between the two vehicles was additionally offset by at least 4" based on the deformation pattern of the liftgate and the width of this structure, resulting in less lateral engagement in the crash test than the subject test. Less lateral engagement results in the impact being concentrated on a smaller area of the Escape. It is possible that the guidance system used for the F-250 was unable to maintain the test setup

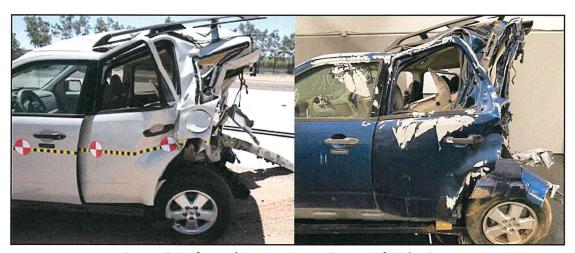
Image 3: Deformed Escape Comparison - Left Side View

14. The tested Escape exhibited less deformation on the left bodyside rearward of the rear door than the subject Escape - Image 3 shows a comparison of the two vehicles, with the tested Escape on the left and the subject vehicle on the right. The tested Escape's C pillar is still visible, and the fuel filler door undeformed whereas the subject Escape's C pillar has been deformed forward of the rear door's trailing edge. The crash tested Escape's roof is also less crushed.

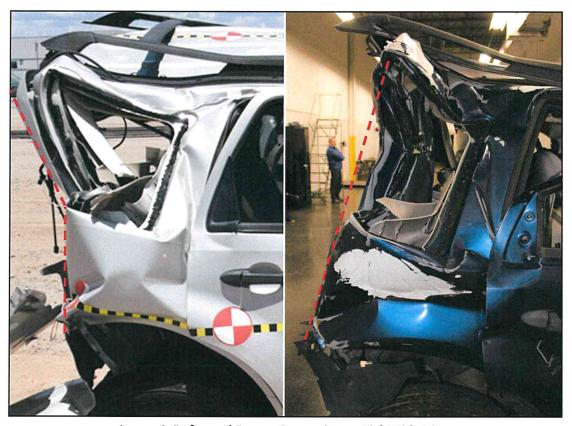
Image 4: Deformed Escape Comparison - Right Side View

15. The tested Escape exhibited less deformation on the right bodyside rearward of the rear door than the subject Escape. Image 4 shows a comparison of the two vehicles, with the tested Escape on the left and the subject vehicle on the right. The crash tested Escape's roof is less deformed, and the rear quarter glass aperture shows less collapse, resulting in the D pillar having an angular

- component rearward rather than being pushed forward, as in the subject Escape, as highlighted by the dashed lines.
- 16. The tested Escape exhibited less rear seat static deformation (forward in vehicle) than the subject Escape – Image 5 shows a comparison of the two vehicles, with the tested Escape on the left and the subject vehicle on the right. The seat back angle is still rearward in the tested Escape, with the headrests adjacent to the C pillar. Whereas the subject Escape's seat back angle is forward, with the headrests significantly forward of the C pillar.

However, the Exponent test does not test Grimes' cargo hypothesis and so by omitting cargo in the testing, he has not followed a scientific methodology to attribute seat deformation to the cargo. Additionally, as noted earlier, there was significantly less upper trunk compartment crush (and roof crush) in the crash test due to the lower engagement height of the F-250. This results in more vertical luggage space being maintained and would allow luggage to move upward rather than forward in the vehicle. The higher ride height of the F-250 in the subject crash resulted in more of the trunk space being crushed (Image 4).

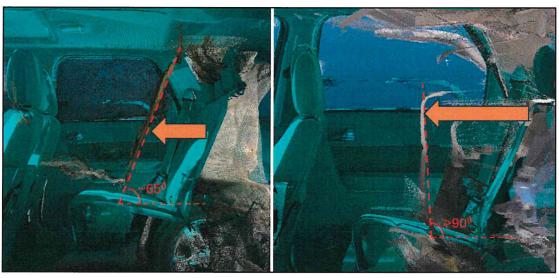
**Image 7: Static Seat Angle Comparison**

- 17. An analysis of overlayed laser scan point cloud data for an exemplar Escape with both the crash test Escape and the subject Escape (Image 6 - crash test on left, subject on right) identifies the following:
  - a. The subject Escape's wheelbase (left side) was almost unchanged at 103".
  - b. The crash test Escape's wheelbase (left side) was reduced by about 5".
  - c. The subject Escape's static seat back angle changed from about 65° to the horizontal to greater than 90°, being rotated forward. See Image 7 with the subject Escape on the right.
  - d. The crash test Escape's static seat back angle (post-test) was largely unchanged from the pre-test condition. See Image 7 with the crash test Escape on the left.

As highlighted earlier, the crash test crush characteristics are significantly changed due to the underbody loading and resulted in rear seat translation rather than rotation (Image 7). The orientation of the occupant's seat was maintained at the original seat back angle and an occupant's head wouldn't be rotated toward the front seat and so would be better protected. The improved vertical structural compatibility in the crash test loaded the underbody and resulted in the second-row survival space being better maintained.

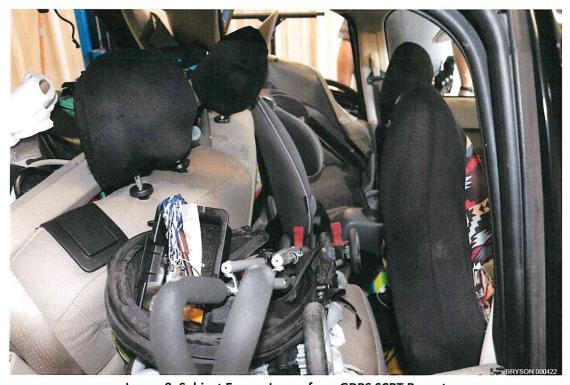
Image 8: Subject Escape Image from GDPS SCRT Report

The Ford Escape test ballast weight used in the crash test does not correspond to either the subject crash condition or normal industry practice for crash testing such as NCAP. The test Escape ballast does not represent the loaded weight of the subject Escape. Both front seats were ballasted with 54lb and 50lb which does not accurately represent the weight of the two occupants (Santana Kelley and Joshua Bryson) at the time of the crash or typical crash dummies at about 167lb each. Locating about 83% (500lb) of the ballast weight in the second-row area is unrepresentative of the weight of the subject Escape during the crash which contained Cohen Bryson (weight 28lb), a car seat (weight about 19lb), a pot plant, a stroller (weight about 11lb) and other small miscellaneous items based on the GDPS SCRT Inspection image – see Image 8. The test was run with the Escape's fuel tank in an empty condition. Typical NHTSA crash test procedures and industry practice is to use an inflammable replacement fluid, such as Stoddard solvent, instead. This ensures the original fuel weight is accurately represented. The ballasting of the crash test Ford Escape was unrepresentative of the subject crash and did not follow normal industry procedures.

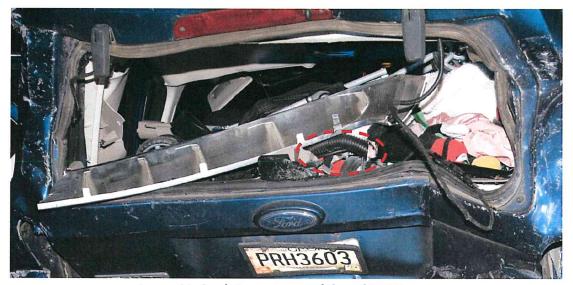
Image 11: Crash Scene Image of the subject Escape

the scene and subsequent inspection (Images 11 and 12) the shop-vac location is on the right side of the luggage compartment. Additionally, the shop-vac canister was significantly crushed during the crash -Image 13. Despite this information, no attempt was made to add the cargo to the crash test to determine the influence, if any, of the cargo on the vehicle intrusions. Grimes' claims that:
